ADVANCED TURBINE ENGINE GAS GENERATOR (ATEGG) FRACTOGRAPHY OF C--ETC(U)

Final Report

4. TITLE (and Subtitle) ADVANCED TURBINE ENGINE GAS GENERATOR (ATEGG) FRACTOGRAPHY OF CAST NICKEL BASE SUPERALLOYS		5. TYPE OF REPORT & PERIOD COVERED Final R&D Materials 1 Oct 1975 - 30 June 1978

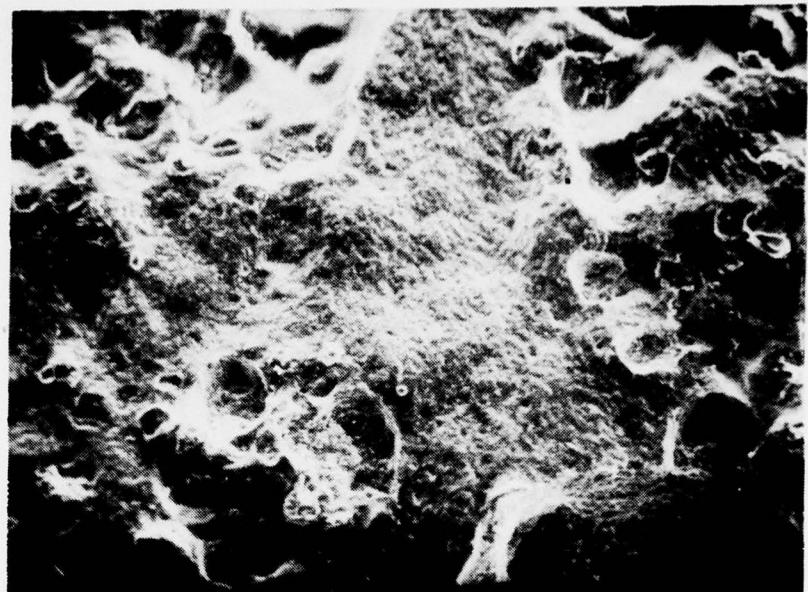
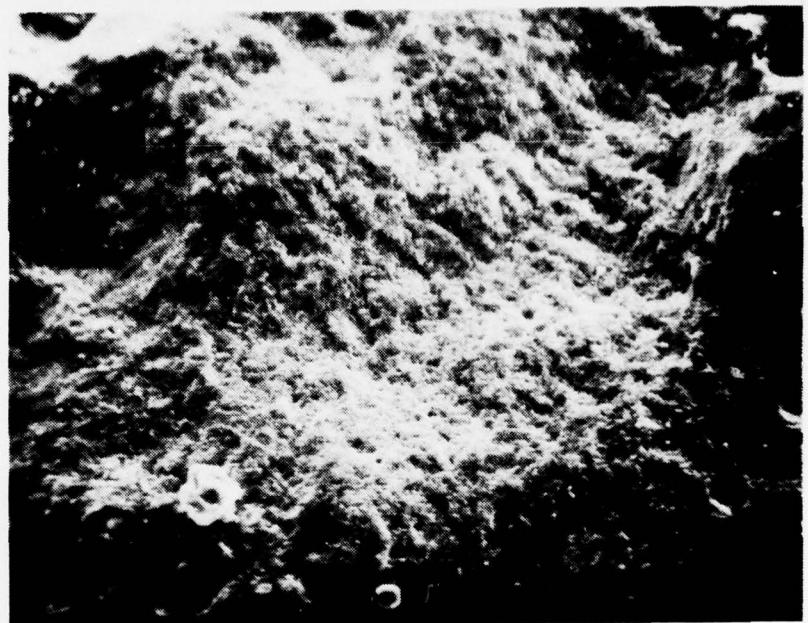
The pp (see Figure 2 for notation) fracture surfaces were found to have definite striations and transgranular plane surfaces when tested in a total strain range of 0.5 percent or less, as shown in Figures 4, 5, 6, and 7. At greater than 0.5 percent total strain, the fracture surface tends to remain transgranular, but is less planar and seems to prefer the interdendritic zones, as seen in Figures 8, 9, and 10. Initiation at these higher strains may be associated with intergranular specimen surface separation (Figure 10), but slip plane formation is still evident in the interior metal at these higher strain rates, as can be seen in Figures 8 and 9.

Figure 4. Specimen 42U-PP-11 - Low Cycle Fatigue, PP Loading,  
Test Temperature - 1600°F Vacuum  
Material - Rene' 80  
Total Strain Range - 0.00296, 271,620 Cycles  
Top 400X, Bottom 1000X  
Transgranular Fatigue Striations

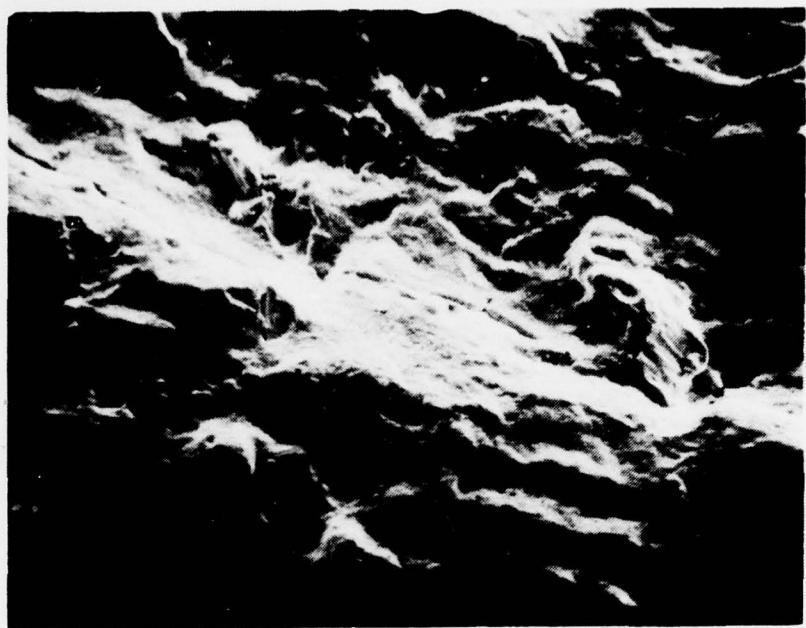
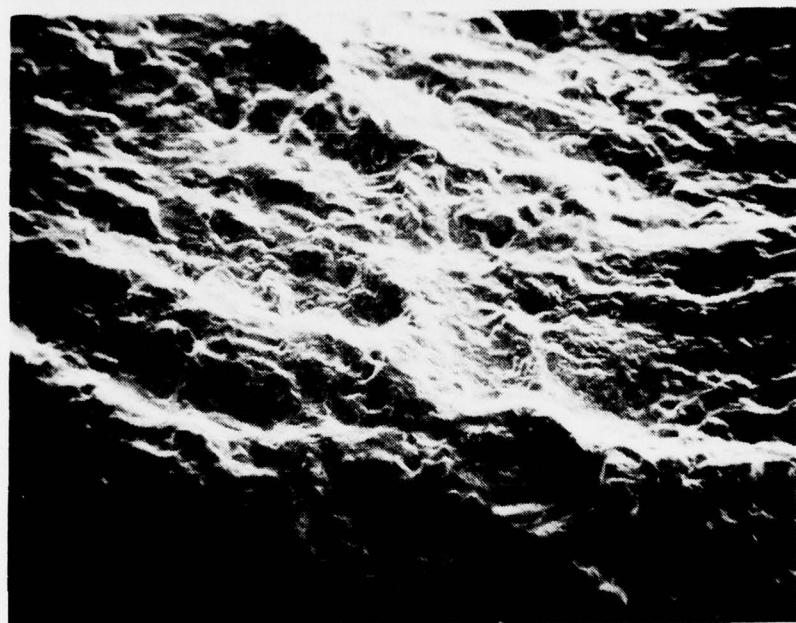
**Figure 5.** Specimen 8U-PP-7 - Low Cycle Fatigue, PP Loading  
Test Temperature - 1832°F Vacuum  
Material - Rene' 80  
Total Strain Range - 0.00247, 22115 Cycles  
Top 400X, Bottom 1000X  
Transgranular Fatigue Striations

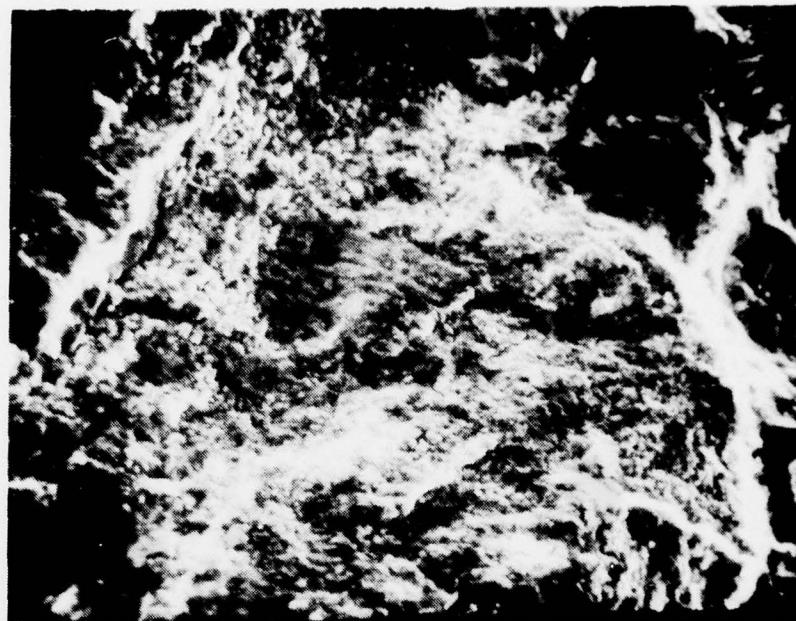
Figure 6. Specimen INN 5-PP - Low Cycle Fatigue, PP Loading  
Test Temperature - 1700°F Air  
Material - IN-100  
Total Strain Range - 0.0036, 29400 Cycles  
Top 400X, Bottom 1000X  
Transgranular Fatigue

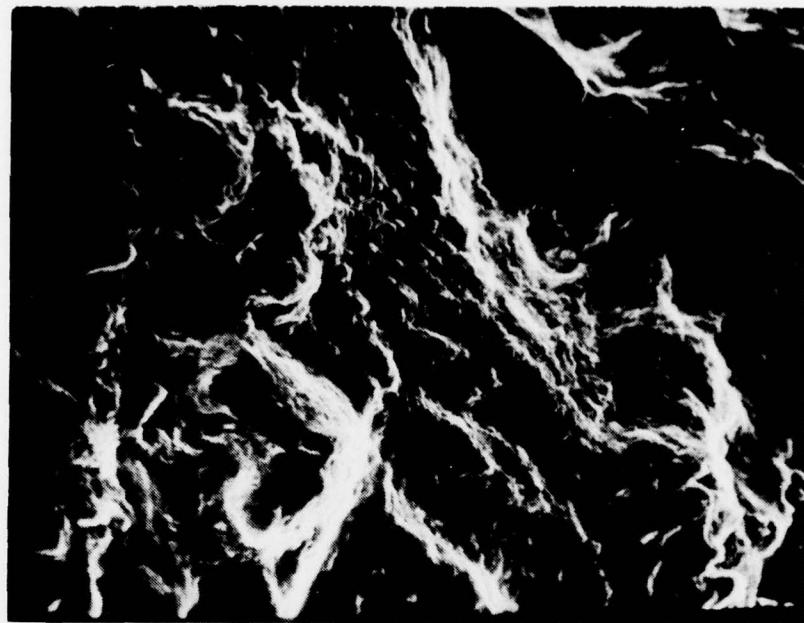
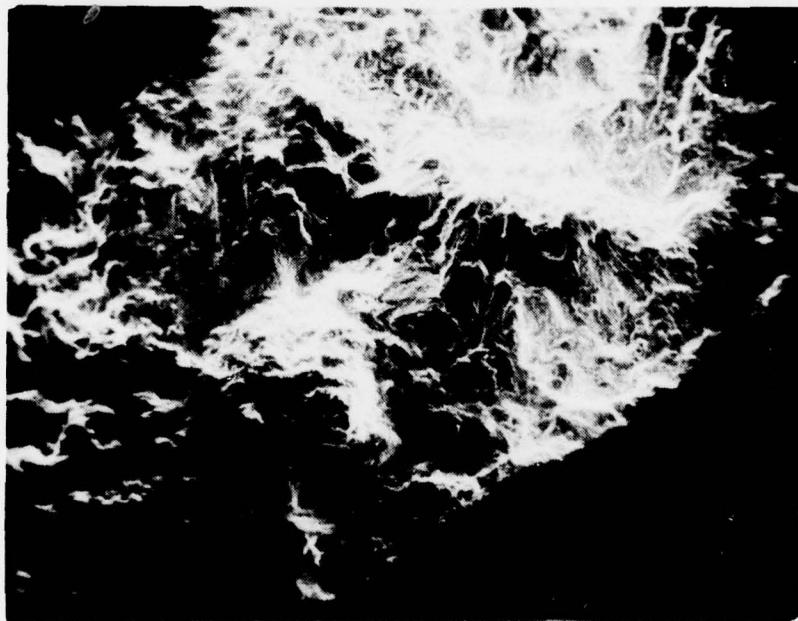
Figure 7. Specimen INN 8-PP - Low Cycle Fatigue, PP Loading  
Test Temperature - 1700°F Air  
Material - IN-100  
Total Strain Range - 0.0049, 1000 Cycles  
Top 400X, Bottom 50X  
Transgranular Fatigue

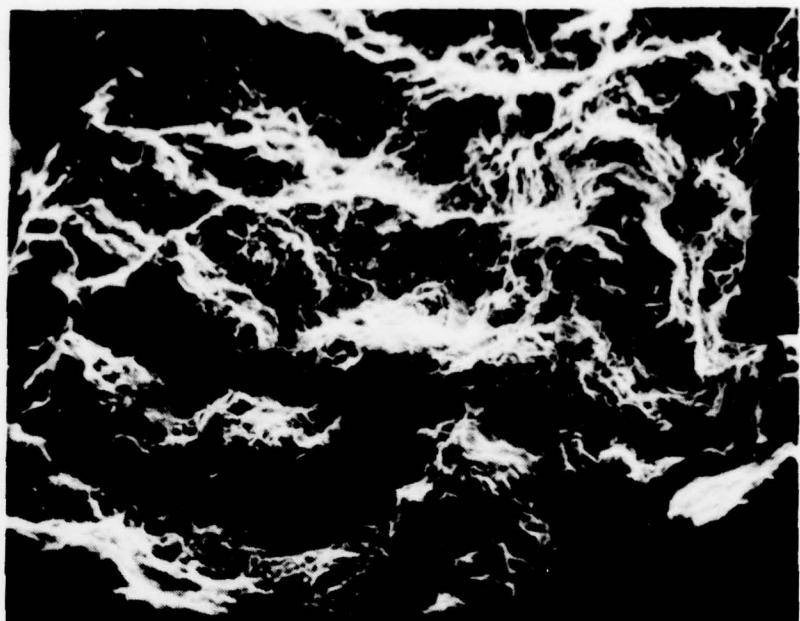
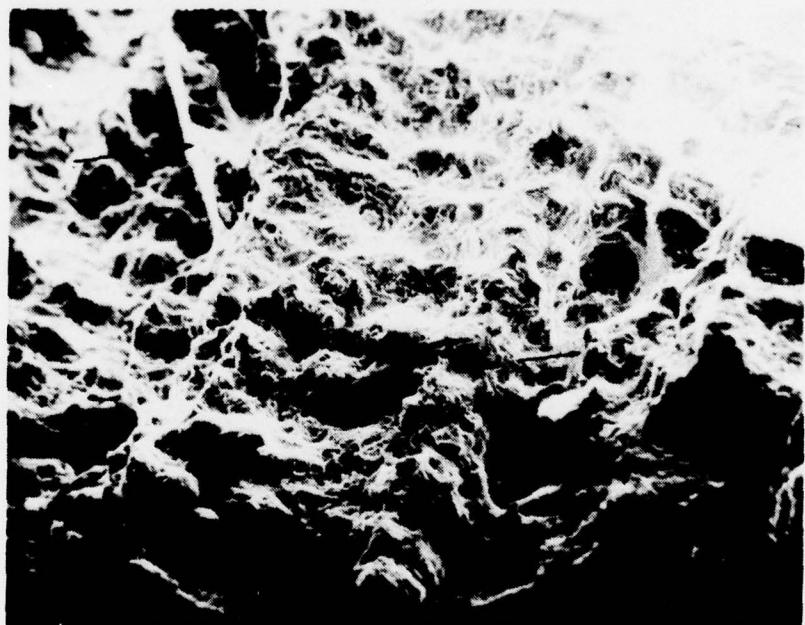
Figure 8. Specimen INN 18-PP - Low Cycle Fatigue, PP Loading  
Test Temperature - 1700°F Air  
Material - IN-100  
Total Strain Range - 0.0064, 300 Cycles  
Top 400X, Bottom 200X  
Dominant Transgranular (Interdendritic) Fatigue  
Note Some Slip Planes (Arrows)

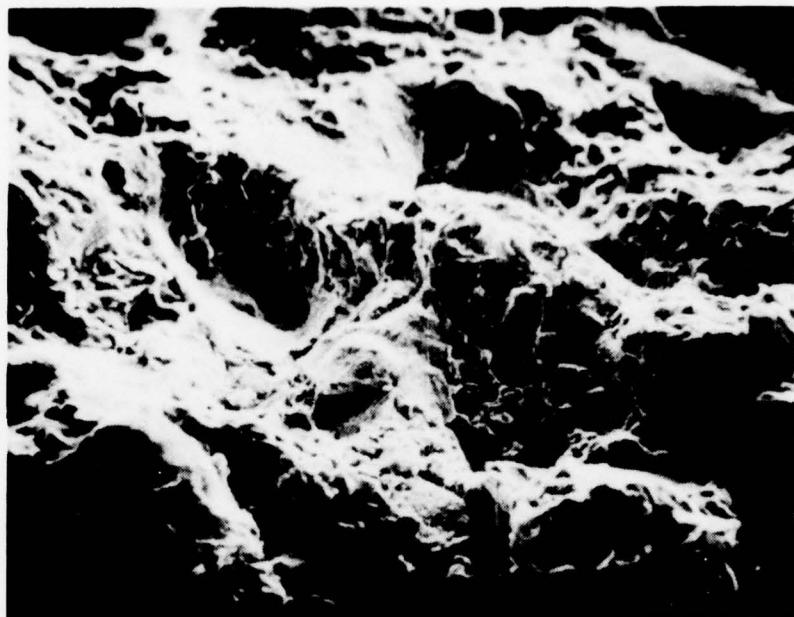
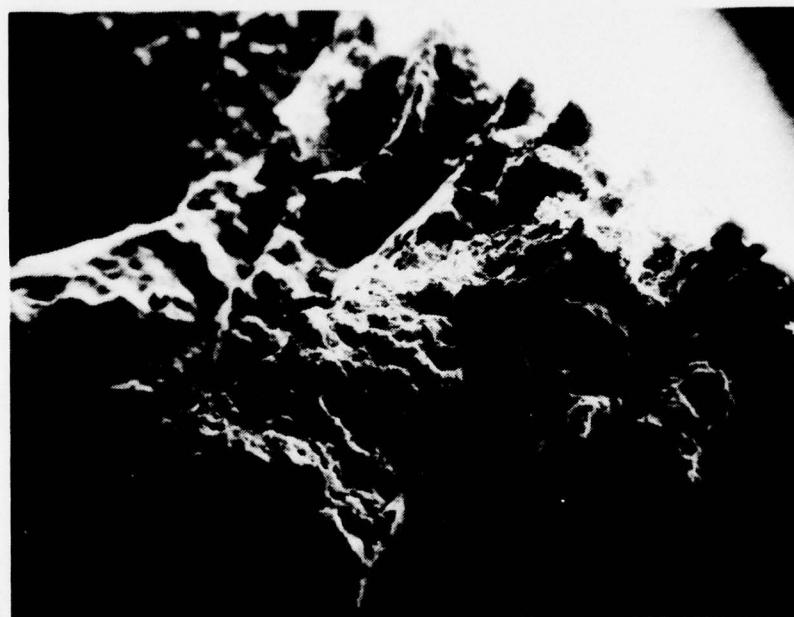
Figure 9. Specimen INN-3-PP - Low Cycle Fatigue, PP Loading  
Test Temperature - 1700° Air  
Material - IN-100  
Total Strain Range - 0.0092, 96 Cycles  
Top 400X, Bottom 50X  
Dominant Transgranular (Interdendritic) Fatigue  
Note Some Slip Planes (Arrow).

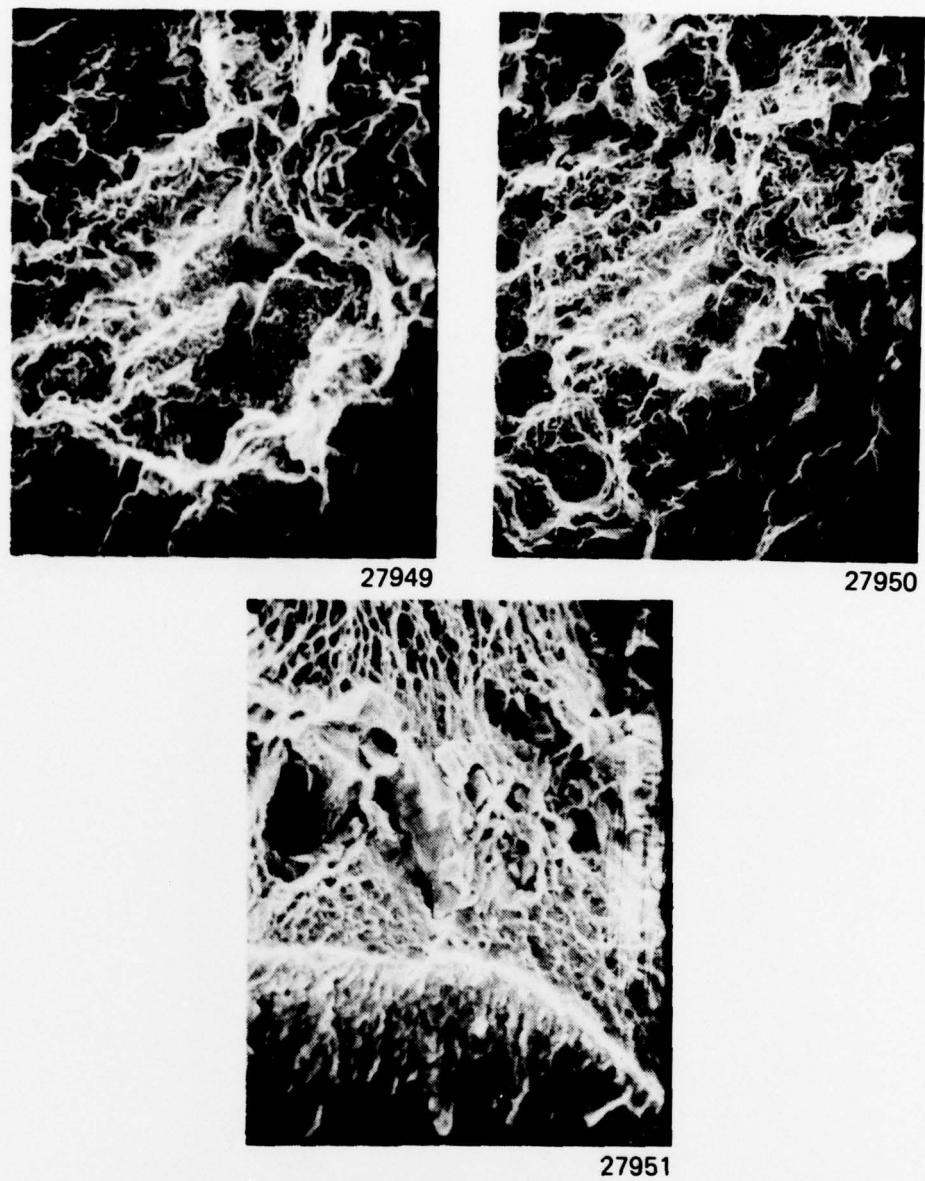
**Figure 10.** Specimen INN 17-PP - Low Cycle Fatigue, PP Loading  
Test Temperature - 1700° Air, Material - IN-100  
Total Strain Range - 0.0113, 160 Cycles  
Top Left 400X, Top Right 200X, Bottom 1000X  
Dominant Transgranular Fatigue  
Intergranular Dimpled Ductile Rupture At Specimen  
Surface Initiation Points (Bottom)

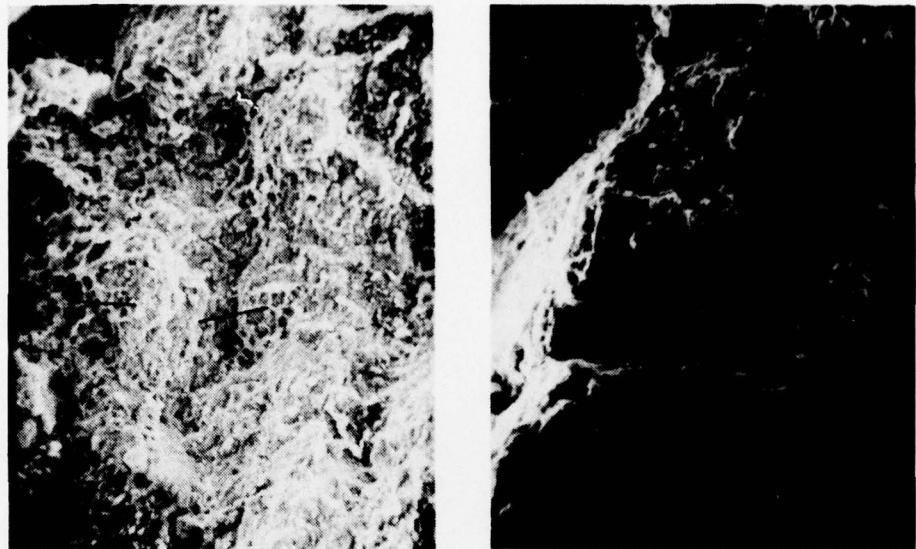
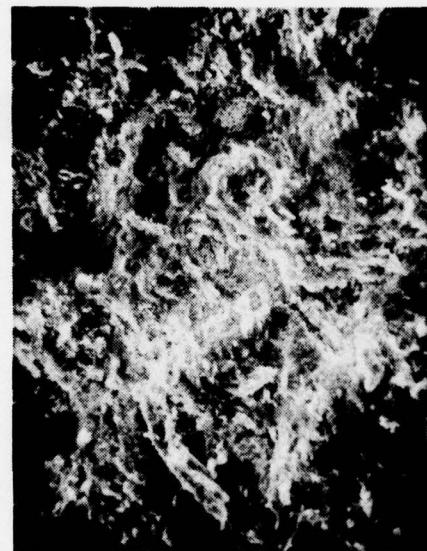
When a creep hold is introduced into the cycle, such as during cc, pc, and cp loading, the low-profile dimpled, grain boundary rupture is generally more prevalent, as is evident in Figures 11, 12, and 13. These generated grain boundary voids tend to become less uniform in size with lower strains (greater number of cycles of failure), as can be seen by comparing Figures 12 and 13, and are probably the result of void coalescence with time, number of cycles, and grain orientation with respect to the loading direction. The presence of heavy surface oxides and surface contacts during reversed loading tends to obliterate some surface characteristics at times, as may be seen in Figure 14, 15, and 16. However, the general intergranular failure is still evident.

**Figure 11.** Specimen INN 11-CP Low Cycle Fatigue, CP Loading  
Test Temperature - 1700°F Air, Material - IN-100  
Total Strain Range - 0.009, 60 Cycles, Test Time 0 163.9 Hrs.  
Top Left 400X, Top Right 1000X, Bottom 400X  
Dominant Grain Boundary Dimpled Ductile Rupture in Creep  
Hold Fatigue.

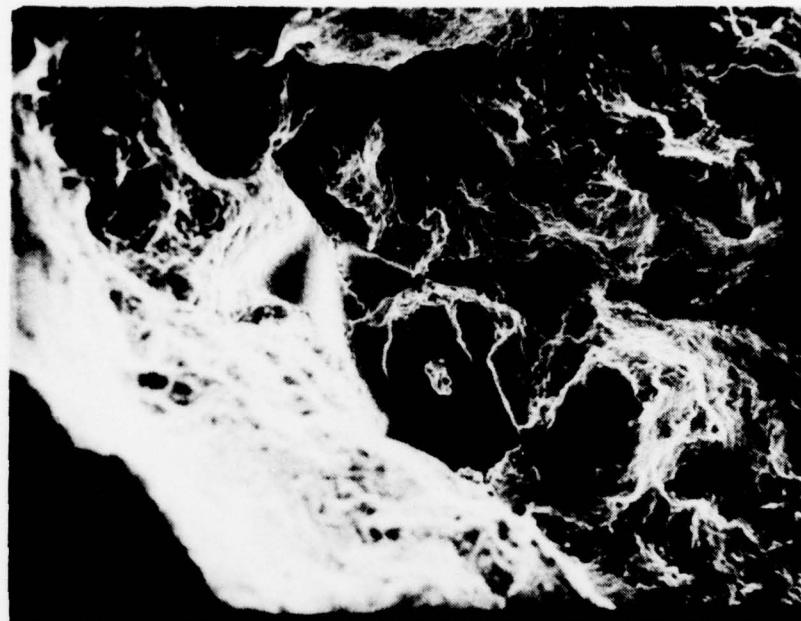
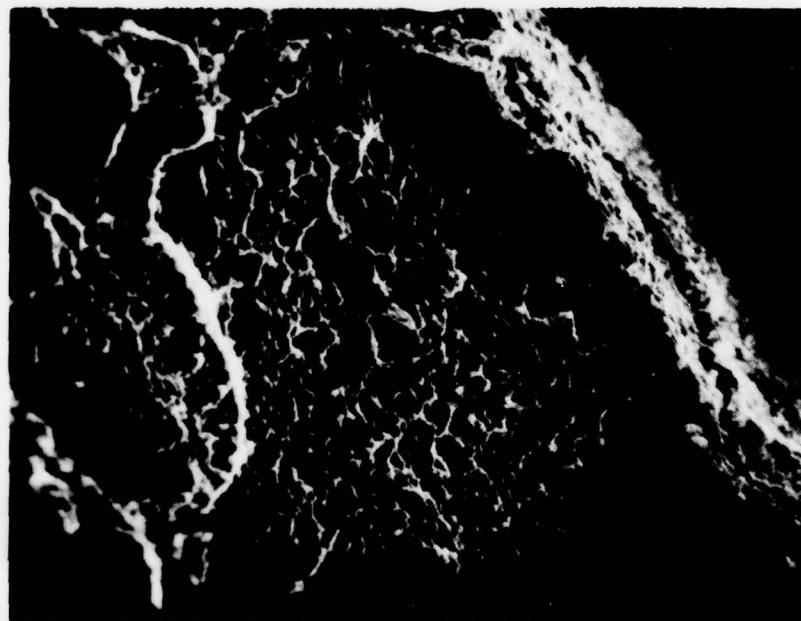
Figure 12. Specimen 89U-PC-8 - Low Cycle Fatigue, PC Loading  
Test Temperature - 1832°F Vacuum  
Material - Rene' 80  
Total Strain Range - .00579, 187 Cycles  
Test Time - 4.9 Hrs.  
Top 400X, Bottom 1000X  
Dominant Grain Boundary Fatigue with Dimpled Ductile Rupture.

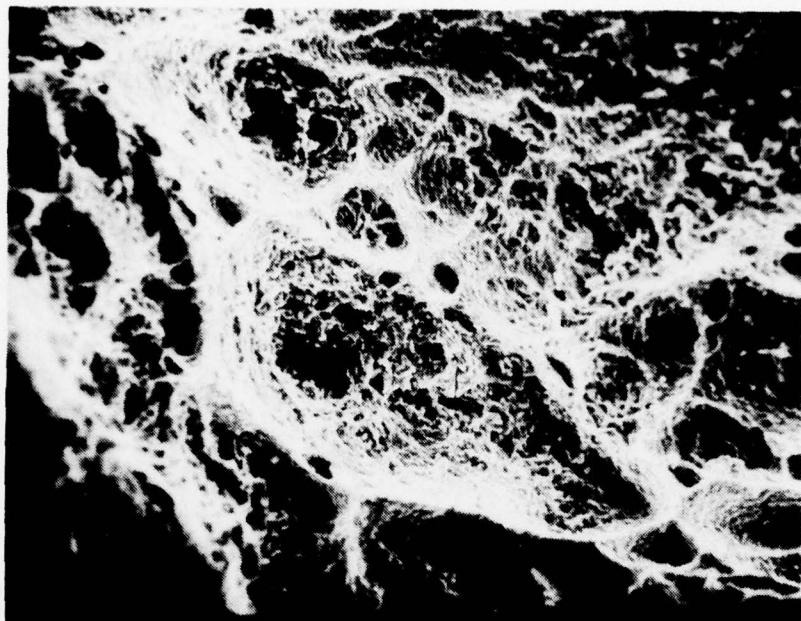
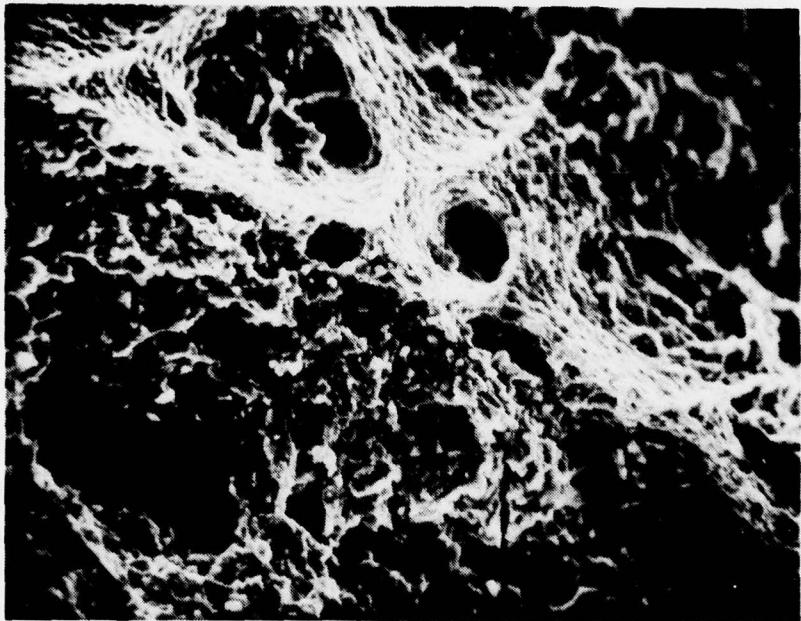
Figure 13. Specimen 26U-PC-8 - Low Cycle Fatigue, PC Loading  
Test Temperature - 1832°F Vacuum, Material - Rene'80  
Total Strain Range - 0.00409, 10164 Cycles  
Test Time - 19.1 Hrs., Top 400X, Bottom 1000X  
Dominant Grain Boundary Fatigue with Dimpled Ductile Rupture.  
Note Larger Dimple Size with Greater Number of Cycles  
(See Figure 12).

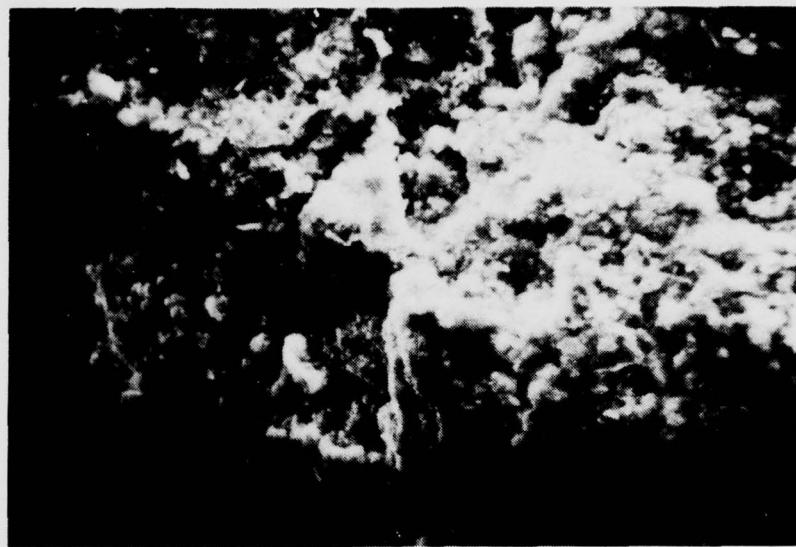
Figure 14. Specimen INN-13-PC - Low Cycle Fatigue, PC Loading  
Test Temperature - 1700°F Air  
Material - IN-100, Total Strain Range - 0.0058, 139 Cycles  
Test Time - 87.3 Hrs., 1000X  
A Compression Dominated Hold can Damage The Grain Boundary  
Fatigue Indications, Particularly in an Air Environment.

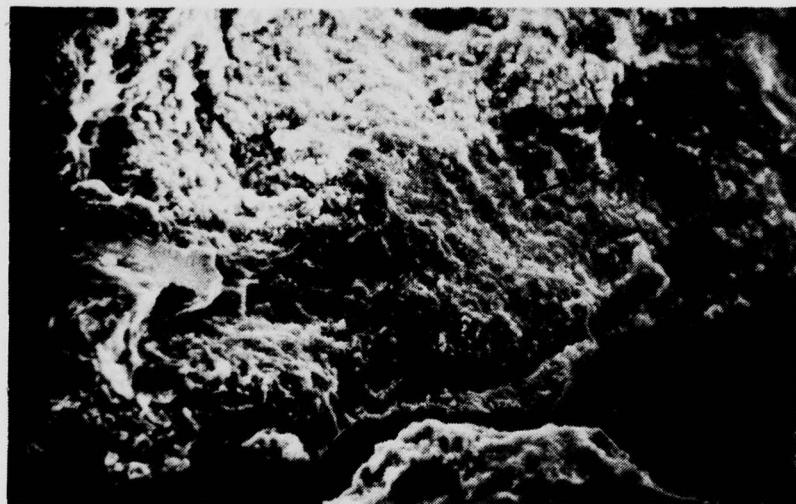
Figure 15. Specimen INN-9-CP - Low Cycle Fatigue, CP Loading  
Test Temperature - 1700°F Air  
Material - IN-100, Total Strain Range - 0.0041, 1100 Cycles  
Test Time - 159.3 Hrs., 400 X  
Reverse Loading Can Damage the Dimples Found in Grain Boundary  
Fatigue, But is Less Damaging in a Tension Hold  
Dominated Fatigue Load.

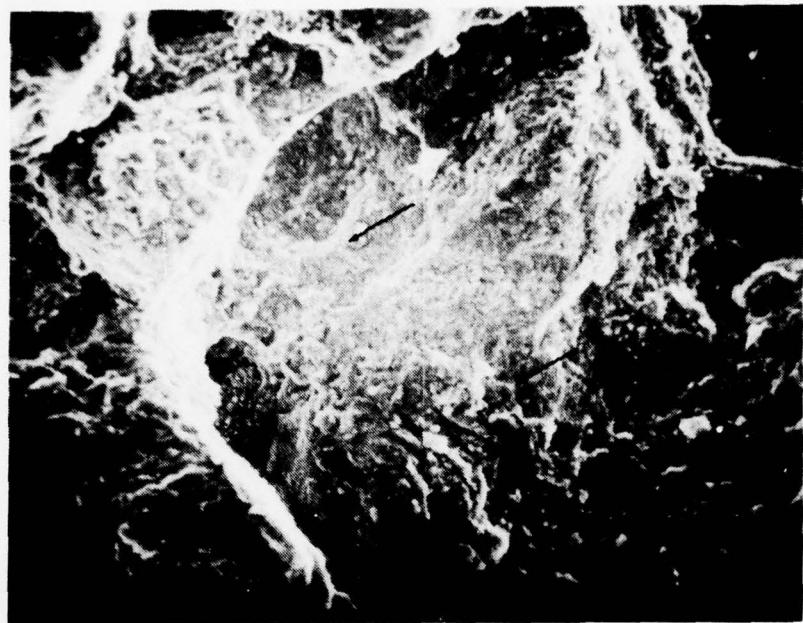
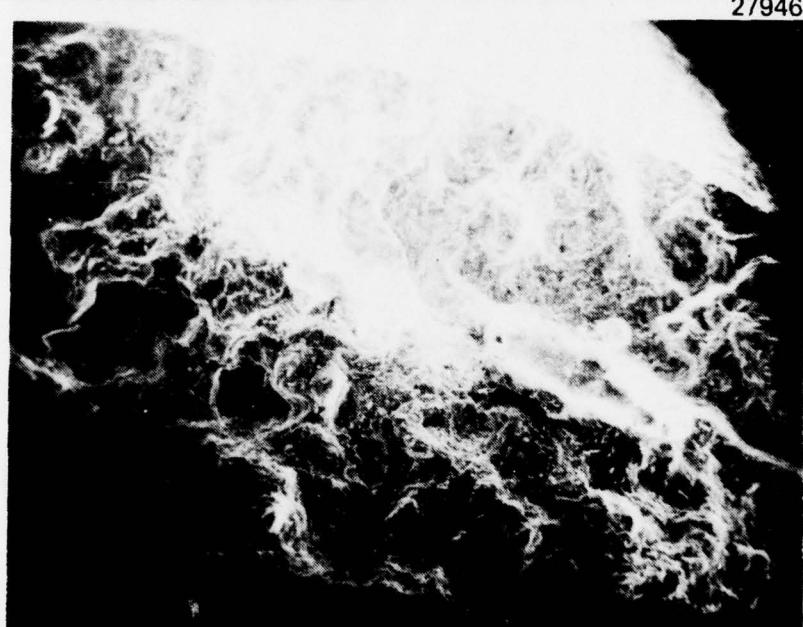
Figure 16. Specimen INN-12-CC - Low Cycle Fatigue, CC Loading  
Test Temperature - 1700°F Air  
Material - IN-100, Total Strain Range - 0.0121, 17 Cycles  
Test Time - 302 Hrs., Top 400X, Bottom 50X  
When the Number of Cycles is Low, Grain Boundary Indications  
(Dimples) are Still Discernible with Creep Hold Times in  
Both Tension and Compression.

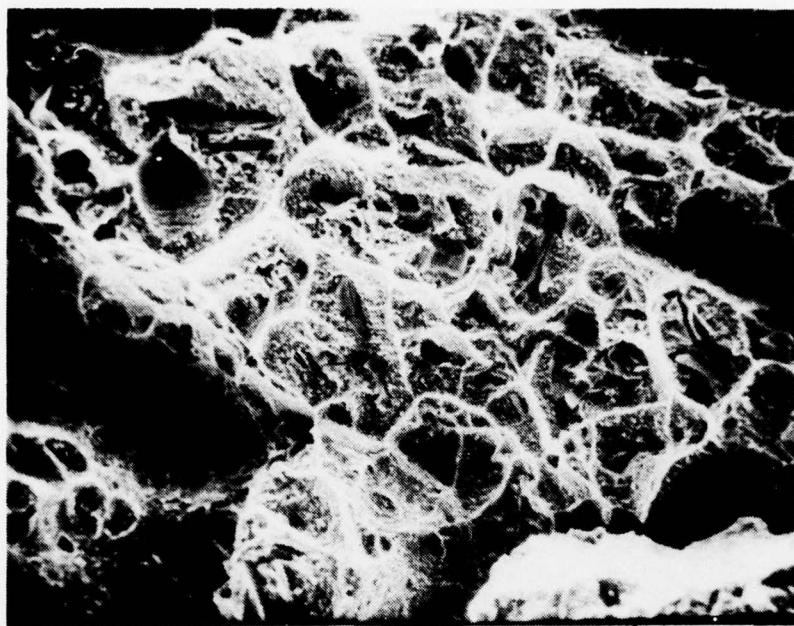
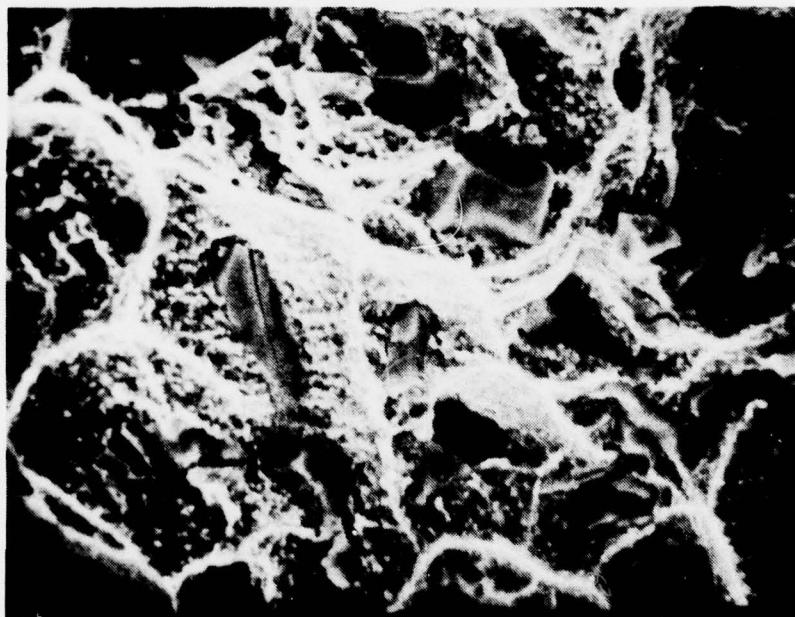
Tensile and short life creep-rupture surfaces are included for the reader to compare fracture surfaces, in Figures 17, 18, 19, and 20. It can be seen that tensile failures at 871°C (1600°F) and 1000°C (1832°F) are both dominated by transgranular rupture and tend to be associated with particulate phases, such as carbide. Short time creep-rupture tends to show evidence of grain boundary influence on the fracture surface, but at 871°C (1600°F) transgranular failure is still present as evidenced by the multiple slip planes in Figure 20.

Figure 17. Specimen 121C-T-1 - Tensile, Test Temperature - 1832°F Vacuum  
Material - Rene' 80. Top 400X, Bottom 1000X  
Short Time Tensile Fracture Surfaces are Transgranular Ductile  
Rupture Even at High Temperature. Note that Tensile  
Fracture is Associated with Carbide Phases in the Matrix.

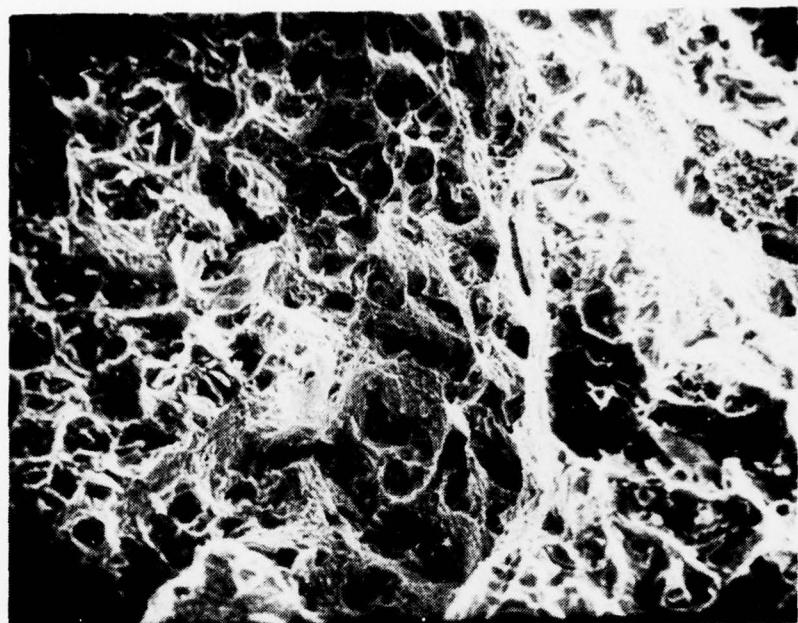
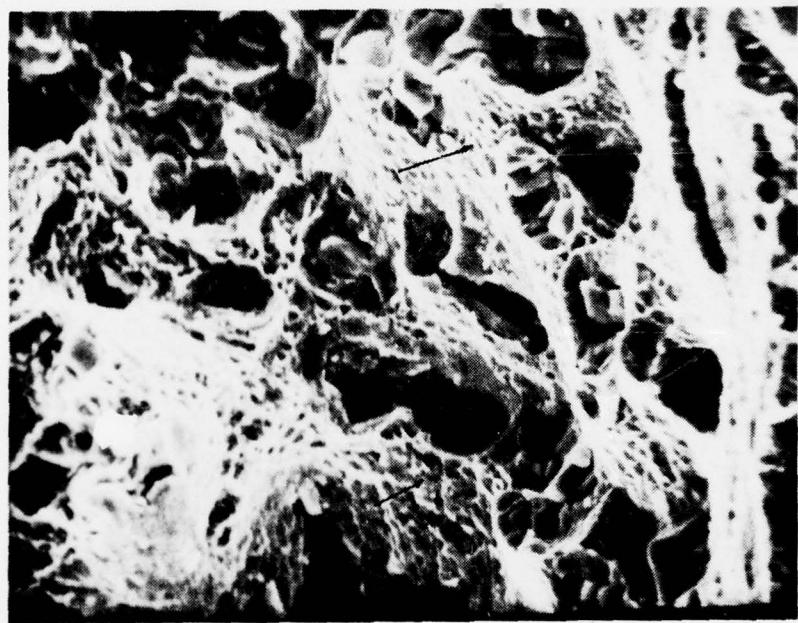
Figure 18. Specimen 123C-T-3 - Tensile, Test Temperature - 1600°F Vacuum Material - Rene' 80, Top 400X, Bottom 1000X Short Time Tensile Fracture Surfaces are Transgranular at 1600°F, and Also Associated with Carbide Phases. However, Notice that the Matrix Also Has Multiple Small Dimples (Arrow Typical). Compare with Figure 17.

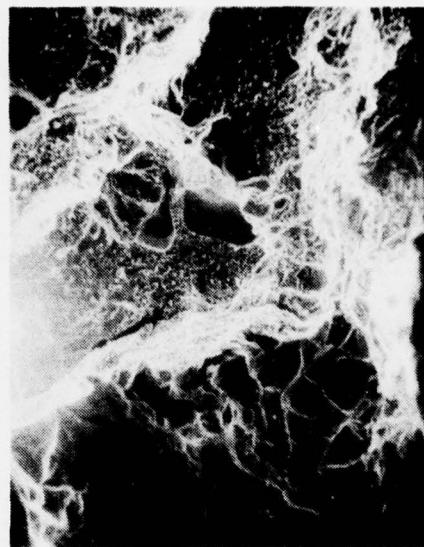
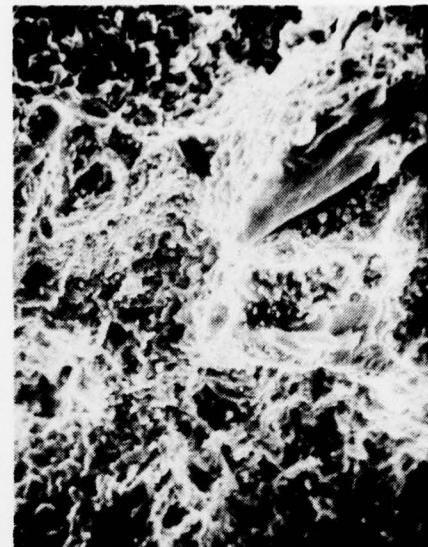
Figure 19. Specimen 25-C-1 - Creep-Rupture at 1832°F Vacuum  
Material - Rene' 80, Top Left 400X, Top Right 1000X, Bottom 6X.  
Short Time Creep-Rupture (0.7 Hrs., This Specimen) Shows Some  
Evidence of Transgranular Influence (See Slip in 6X Photo),  
but Creep is Evident at Grain Boundaries. It is Interesting to  
Compare the 1000X Surface Texture to the LCF Specimen of Figure 13.

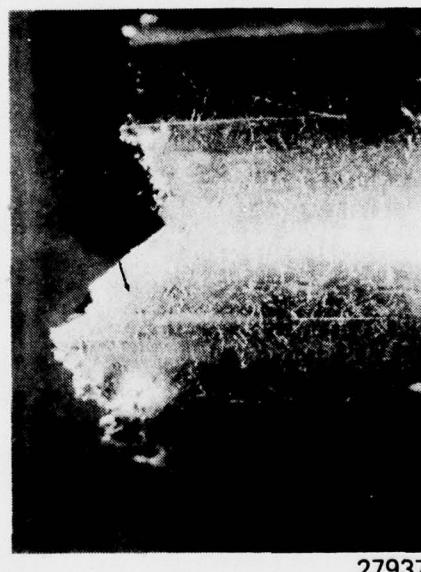
**Figure 20.** Specimen 37U-C-7 - Creep Rupture at 1600°F Vacuum  
Material - Rene' 80. Top Left 400X, Top Right 1000X, Bottom 6X.  
Short Time Creep Rupture (2.1 Hrs. This Specimen) Shows Heavy  
Influence of Transgranular (Slip Planes at Arrow in 1000X Photo  
and 6X Photo) Fracture, But Creep Effects are Very Apparent With  
Grain Boundary Dimpled Structure (Arrow) in 1000X Photo.
